# Manhole Inspection Summary

Manhole # S45G\_\_002MH

Insp Date: **7/15/08 11:13 AM**

**Location** Address: **202 1/2 s castle st**

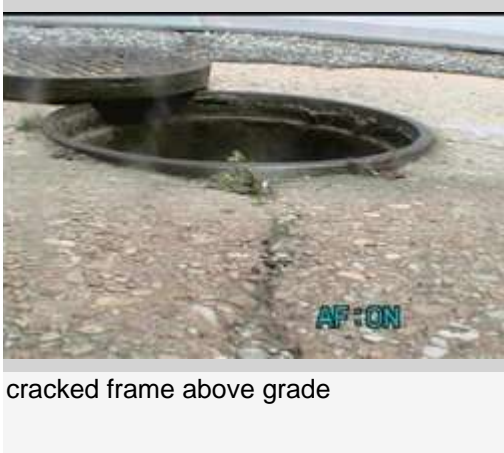
Defect 5

**Frame** Offset: **2** (in.) Condition: ☐ Sound ☒ **Cracked** ☐ Leaks

cracked frame above grade

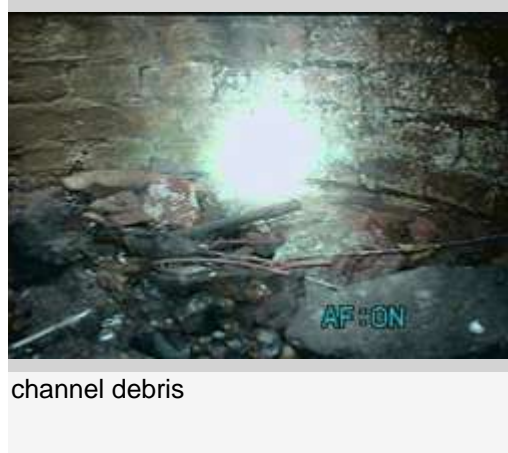
Defect 4

Condition: ☐ Sound ☐ Cracked ☐ Root Intrusion ☐ Deteriorated ☐ Leaks ☒ **Debris**

channel debris

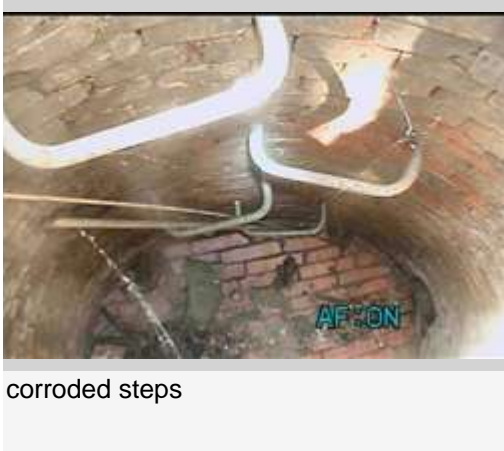
Defect 3

**Steps** Count: **4** Missing: **0** ☒ **Corroded**

corroded steps

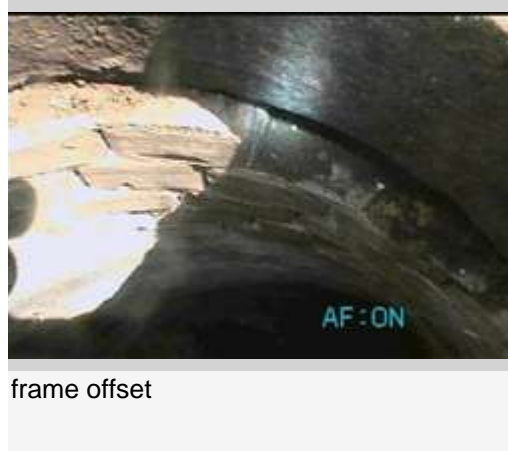
Defect 2

frame offset

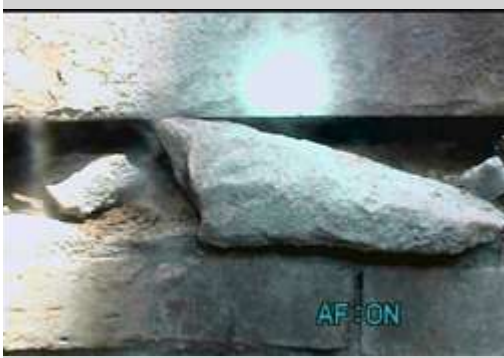
### Defect 1

Condition: ☐ Sound ☐ Cracked ☐ Root Intrusion ☒ **Loose Brick** ☐ Deteriorated

loose bricks chimney frame adj
